# Interfacial phenomena in optical fibre embedded systems

Irina Severin, Mihai Caramihai, Rochdi El Abdi, Marcel Poulain

Irina Severin, Mihai Caramihai, Rochdi El Abdi, Marcel Poulain. Interfacial phenomena in optical fibre embedded systems. *Composite Structures*, 2019, 224, pp.111029. 10.1016/j.compstruct.2019.111029 . hal-02280474

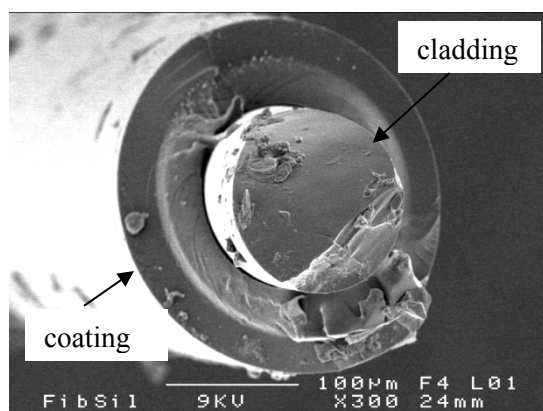
Figure 1. SEM of 125/250 silica optical fibre (cladding 125  $\mu\text{m}$ , two layer epoxy-acrylate coating 250  $\mu\text{m}$ )

The silica cladding of 125  $\mu\text{m}$  in diameter is protected with two layer epoxy-acrylate polymer coating of 250  $\mu\text{m}$  in diameter (Fig. 1). Other fibers consist of silica cladding of 80  $\mu\text{m}$  in diameter protected with one layer acrylate polymer of 101.8  $\mu\text{m}$  in diameter (Fig. 2) or two layers of 172  $\mu\text{m}$  in diameter. In order to protect the sensitive glass surface, the inner layer coating is soft, allowing to glue in some way the micro-cracks, to inhibit their evolution and to prevent water molecule reaction. In order to protect the fiber against external aggression, the external coating is hard, thus manipulation for testing or cabling is facilitated. Despite the balanced ratio of low cost and the good performance, the main limitation of the epoxy-acrylate coating (Mid-Term Dual Acrylate Enhanced Performance) lies in the high sensitivity to chemical reagents, including humidity. That's why for specific applications, hermetic carbon coating (in our experimental campaign H SOF Verrillon) or inorganic ones may be applied acting as an efficient barrier against corrosive reagents.

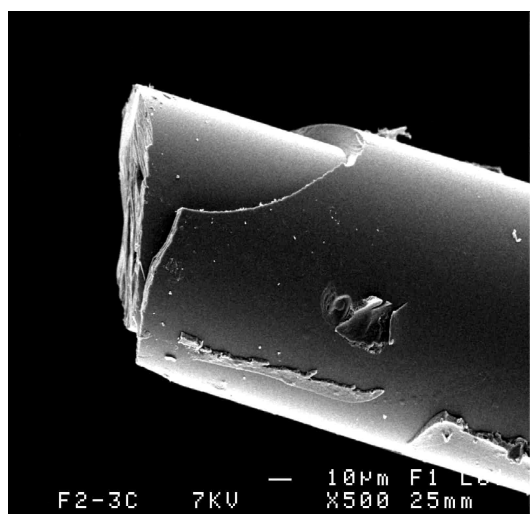
Figure 2. SEM of 80/101.8 silica optical fibre (cladding 80  $\mu\text{m}$ , single layer coating 101.8  $\mu\text{m}$ )

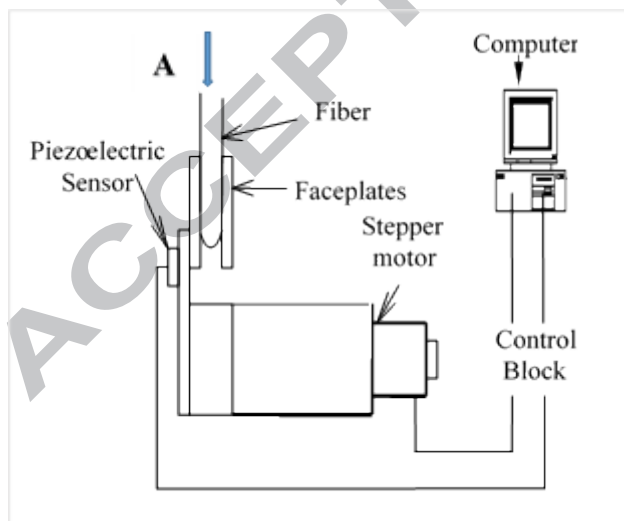
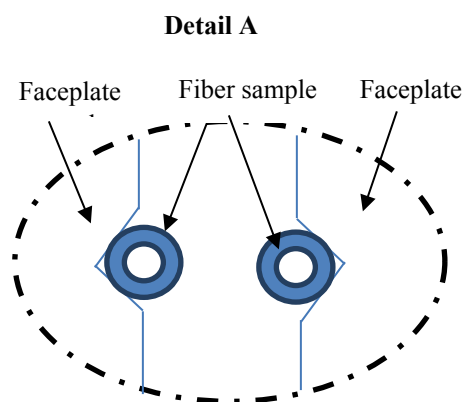
Figure 3. Two point bend test setup

In line with the International Standard [15], dynamic testing was performed in controlled environment at 18°C ( $\pm 2^\circ\text{C}$ ) temperature and 45% ( $\pm 5\%$ ) relative humidity, using two different procedures: two point bending testing experimental bench (Fig. 3) and tensile testing bench Lloyds LR 50K (Fig. 4). Testing samples geometry is given in table 2. In both dynamic testing procedures, four different strain rates were applied and for each testing conditions series of 30 samples were registered. Then the Weibull plots were traced and, in several cases, the stress corrosion factor  $n_d$  was calculated, too.

The two point bending testing doesn't replace the tensile testing as fiber strength measurement ; due to the small length fiber sample (10 cm) placed between the grooved faceplates (Fig. 3 detail A) and the short time necessary for testing manipulations, too, valuable information has been provided to compare defect size distribution and micro-cracks evolution [17].

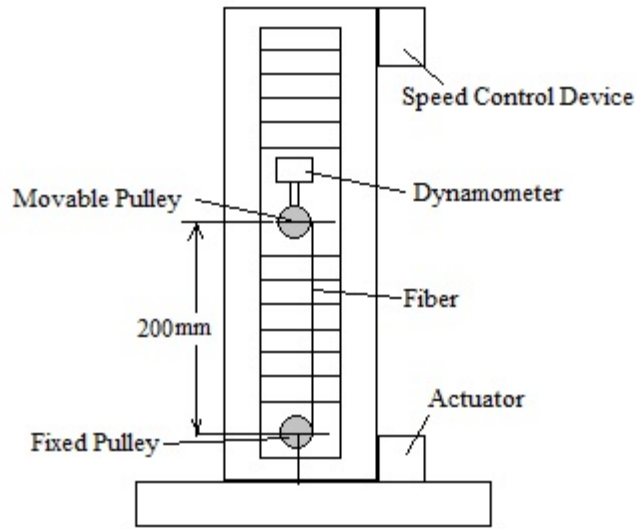
Figure 4. Dynamic tensile test setup

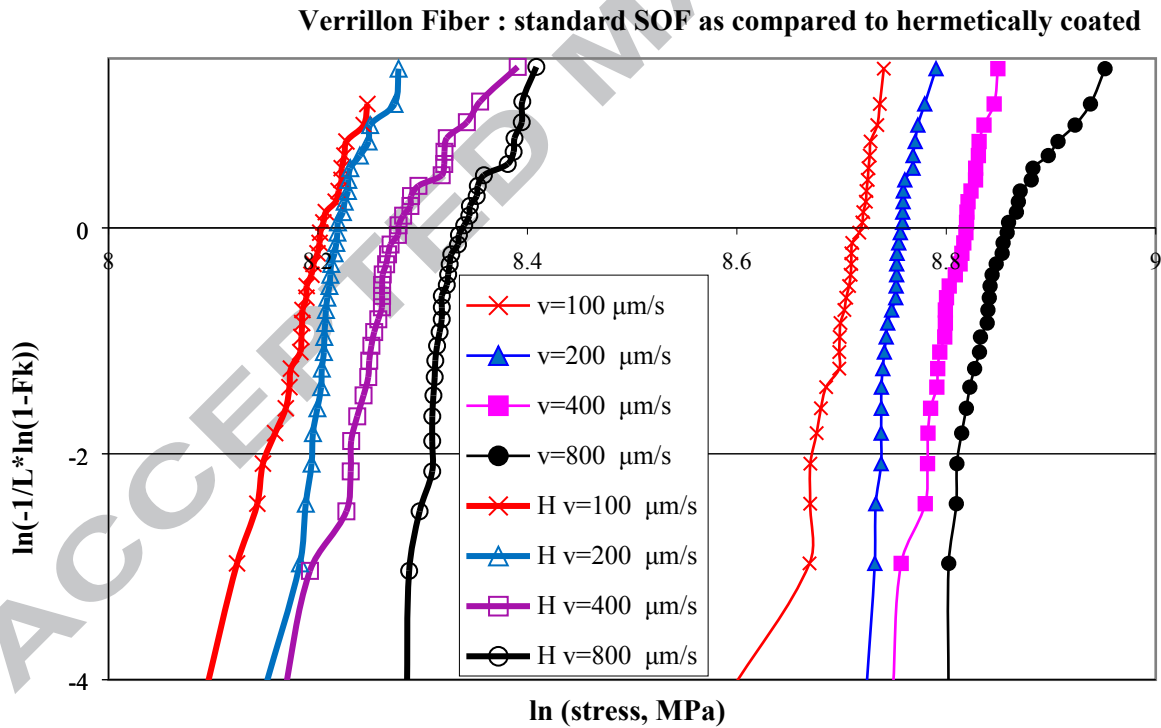
Figure 5. The effect of the hermetical (H) in-line deposition on the mechanical strength of as-received SOF for different strain rates (in  $\mu\text{m/s}$ )

Presenting on the same graph the Weibull diagrams for Verrillon standard optical fibers (SOF) as compared to the Verrillon fiber with the hermetic in-line deposition (H SOF) (Fig. 5), following the improved fabrication technology, one may notice the similar behavior in terms of flaw size dispersion (Weibull plots with the similar slope), but a significant decrease of the mean stress. The results dispersion is broader for the extreme strain rates (100 and 800  $\mu\text{m/s}$ ) and slightly steeper for the median ones (200 and 400  $\mu\text{m/s}$ ). The median failure stress (the stress corresponding to the 50% failure probability  $F_K$ ) varied between 6 and 7 GPa for the standard SOF. In the case of non-aged (as-received) hermetical coated H SOF, the median failure stress decreased to 3.6 and 4.1 GPa.

For tested fibre length and testing time economy reasons, dynamic testing appears more effective. The standard silica optical fiber with double epoxy-acrylate coating, tested in accordance with the International standard [15], has good mechanical strength ranging up to 7 GPa, as given by the Weibull

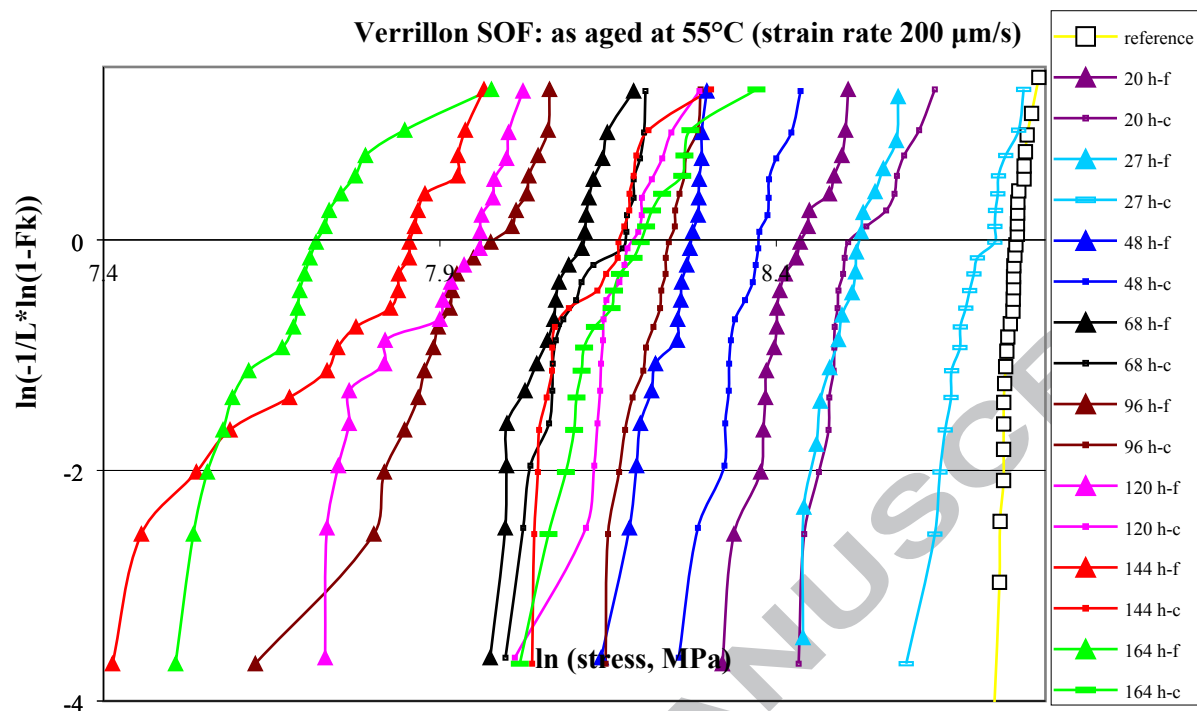
Figure 6. Fibre strength decrease following exposure to fluorinated reagents (in legend the aging duration, in hours; *f* far from vapours release, *c* close to vapours release)

The fluorinated environment is very aggressive for silica. The Weibull diagrams for the standard silica optical fibers reveal the significant decrease of the fiber strength, losing up to  $\frac{3}{4}$  of the as-received

strength (Fig. 6) together with a broader distribution (as compared to the as-received fibers), indicating the extension of extrinsic flaws. The standard SOF damaged extensively after 12 days of exposure with a difference of about 1 GPa between the two series, depending on the fibers' position ( $f$ ,  $c$ ) in the cylinder disposal during the chemical aging.

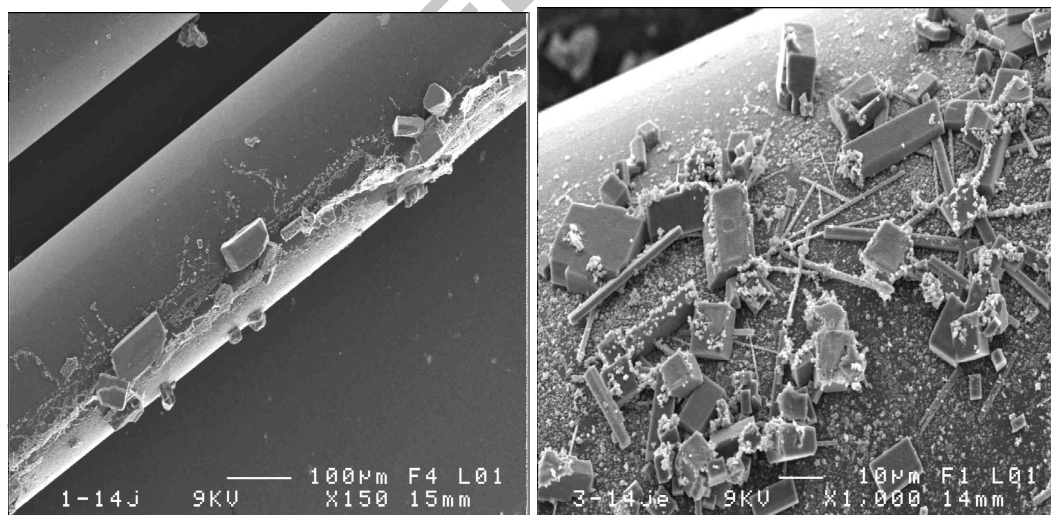
Figure 7. Crystal deposits along the fibre subjected to fluorinated vapours

The SEM indicated numerous crystal deposits along the fiber independent of the sample position in the disposal (Fig. 7). The chemical analysis of crystal deposition revealed fluoride presence, but silicon too, concluding that silicon diffused from silica cladding and segregated in a solid phase generated from  $\text{Si}_4\text{F}$ . Contrary to the lower mechanical strength of the as-received H SOF compared to the SOF, the hermetic deposition leads to an improved behaviour to the fluorinated environment, with a steady state until 12 days of exposure and starting to decrease from 14 days (Fig. 8). Even in these conditions the decrease is less than 10% of the initial strength, so as the hermetic deposition leads to resistance to chemical reagents. In Fig. 9, the Weibull diagrams are compared for the four strain rates corresponding to H SOF as-aged for long duration (14 days). One may suppose that the environment is saturated as the fiber's mechanical behavior does not depend on the vapor release position. Unfortunately, the silica end exhibited catastrophic damage (Fig. 10) attributed to continuous etching. Once the process is initiated, the silica structure has been continuously destroyed. The carbon protection appears quite effective at the interface silica cladding – polymer coating, but if the reagent reaches the unprotected silica, the process appears irreversible and highly reactive.

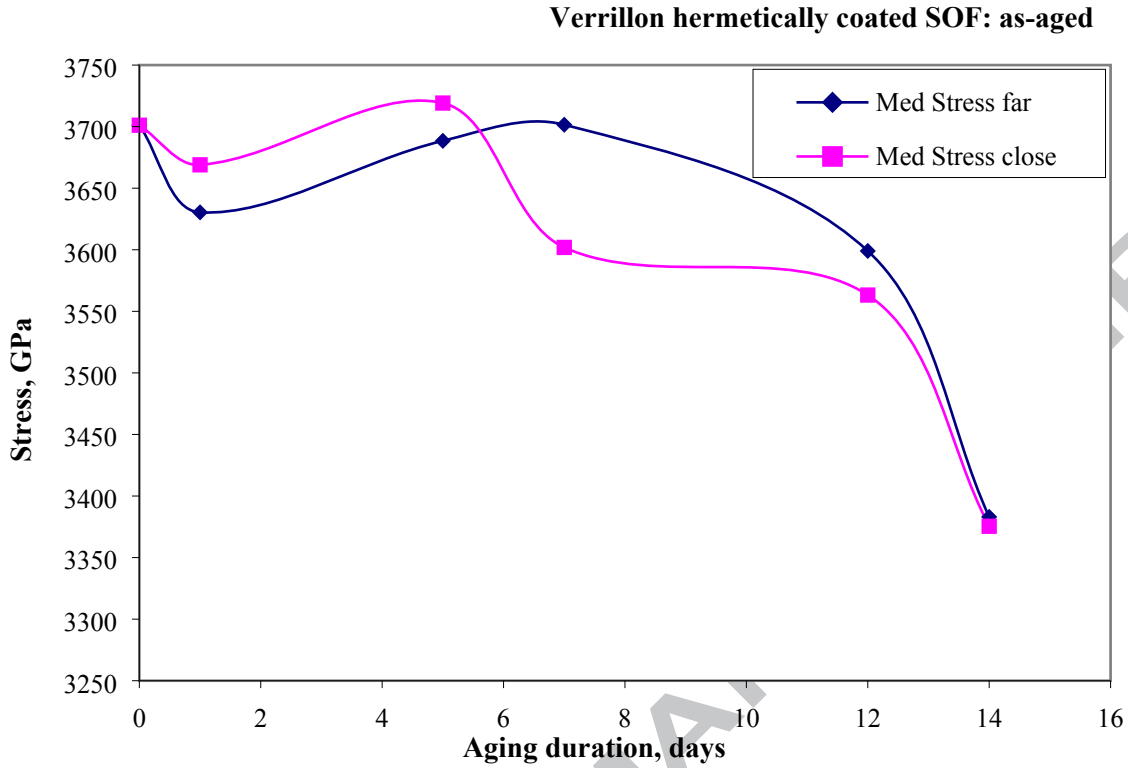
Figure 8. Influence of hermetical protection of silica cladding in aging conditions in fluorinated environment at 55°C

In order to improve the fibre reliability, hydrogen diffusion through the silica cladding surface should be avoided. In-line deposition of a thin layer of diamond like carbon, followed by the subsequent polymer coating polymerisation, may improve the fabrication process. The hermetic coated fibres present lower mechanical strength ranging between 3.6 to 4.1 GPa (Fig. 5), but subjected to fluorinated vapours, known as critical for silica [7], the carbon protection appeared quite effective. Extensive exposure (12 days) of the hermetic coated fibres leads to a decrease of less than 10 % of the initial strength (Fig. 8).

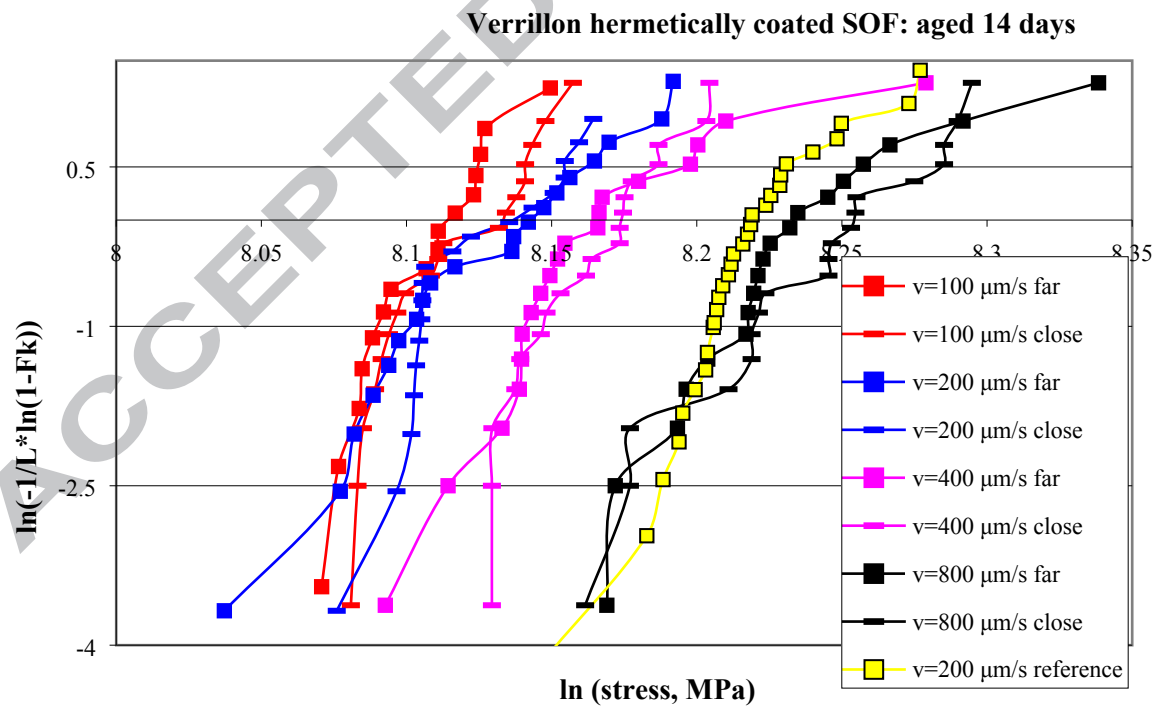
Figure 9. Weibull plots of H SOF aged in harsh conditions

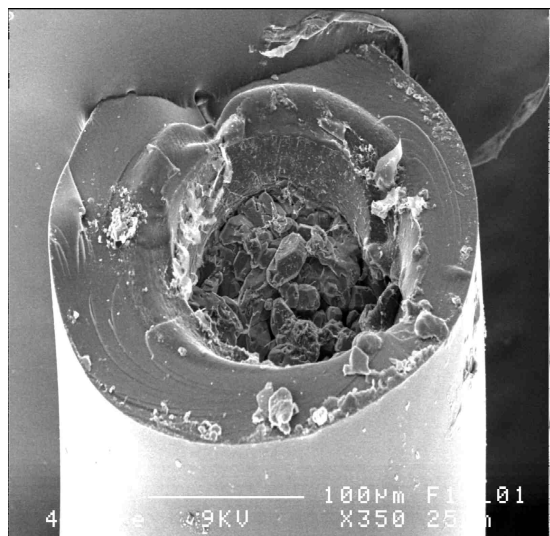
Figure 10. Harsh etching of unprotected end of silica cladding in fluorinated environment (H SOF)

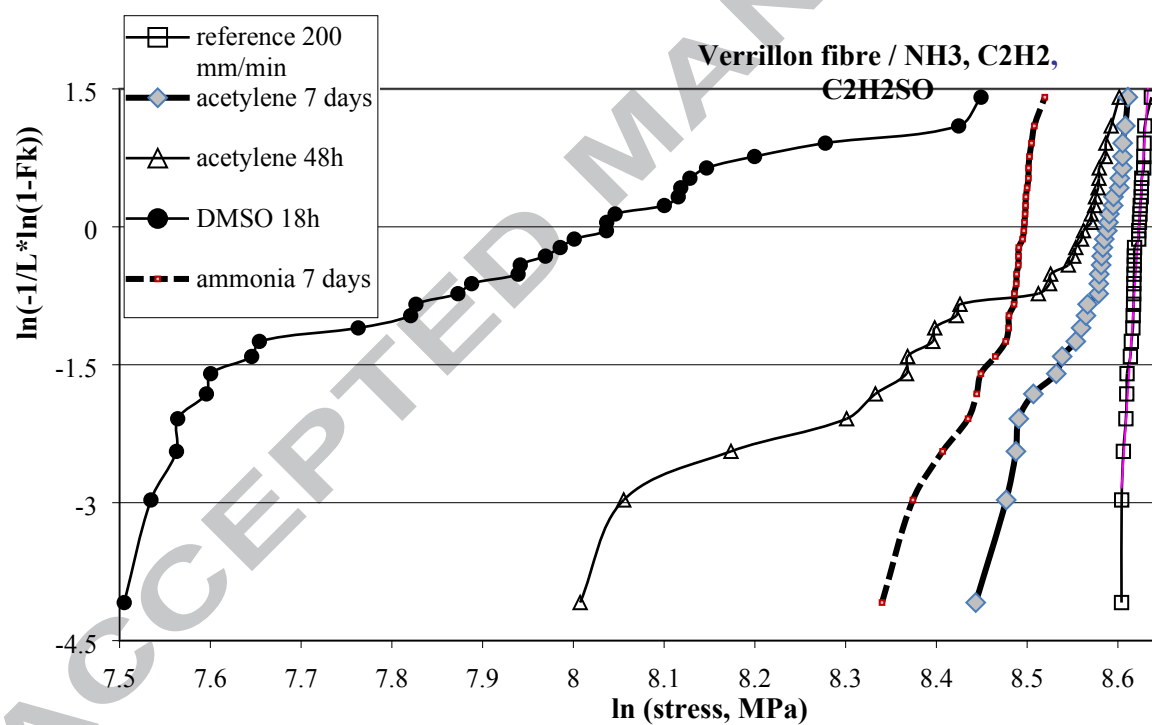
Figure 11. Effect of reagents on SOF mechanical strength

The aged samples were dynamically tensile tested, the stress to fracture was registered and Weibull plots were produced as previously discussed (Fig. 11).

Comparing the results distribution of the reference fiber (as-received) with the as-aged ones in different reagents, the effect appears obvious with a transition from steeper (as received) to broader (as-aged) aspect; the mechanical strength decreases, too.

Exposure to ammonia reagent led to the strength decrease, the Weibull plot presenting a mono-modal distribution, similar to the reference (non-aged SOF). A similar distribution was registered following exposure to acetylene for the same duration (7 days), but the decrease was less severe. The most aggressive reagent was DMSO in liquid phase, an organo-sulphur compound and universal solvent capable to stabilize cell membranes under rapidly changing conditions. The broader scattering, attributed to multimodal distribution, and the significant loss in mechanical resistance were noticed for an exposure

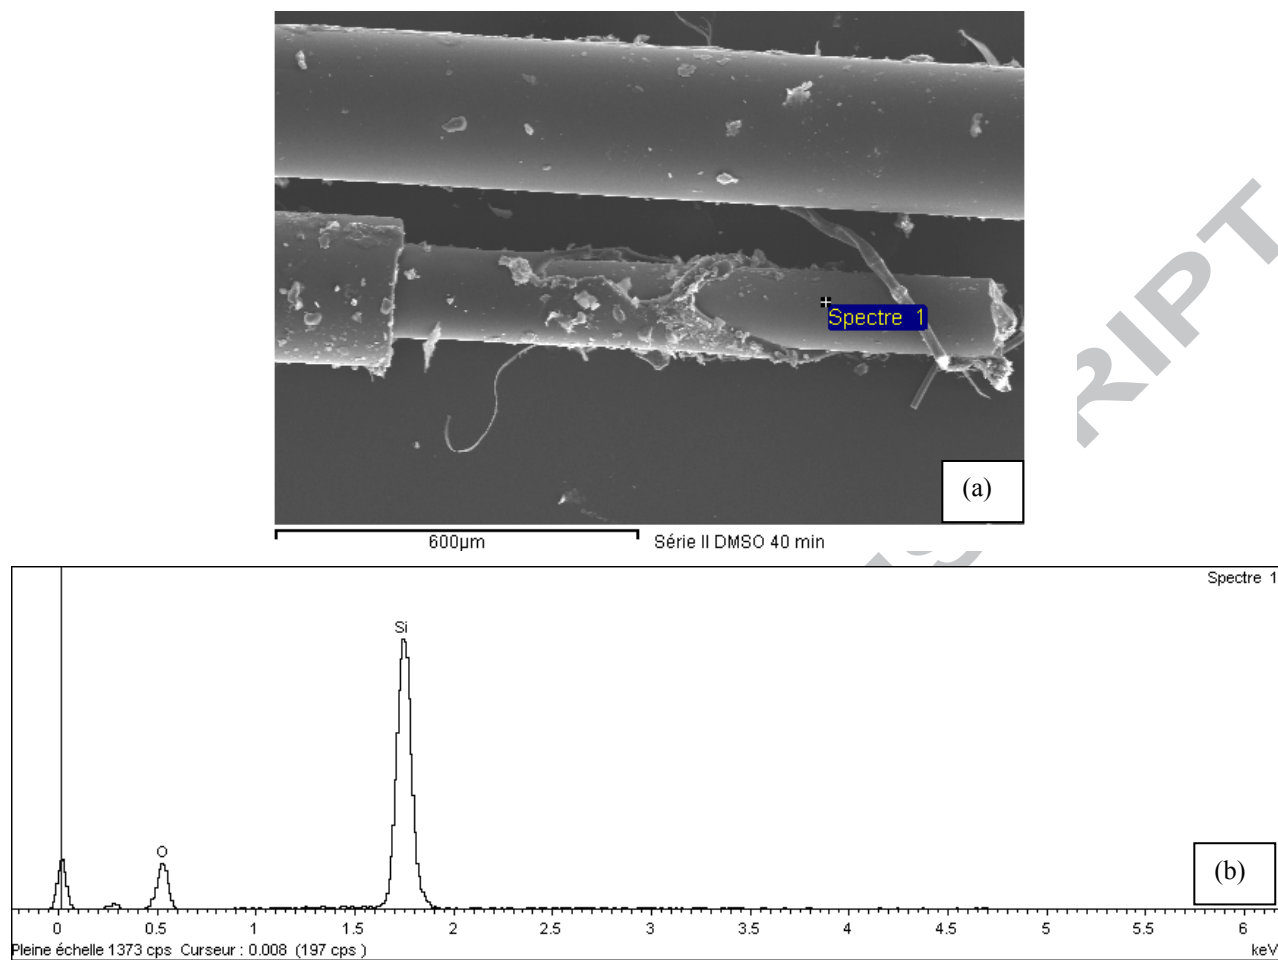
Figure 12. SEM (a) and chemical analysis (b) of DMSO aged SOF for 40 minutes: polymer coating peeling-off

Finally, relevant samples of etched fibres were investigated by scanning electron microscopy (SEM) and subjected to chemical analysis using a JEOL JSM-6301F scanning microscope. The polymer coating appears detached from the silica subsequent aging in DMSO (Fig. 12-a and 13-a) and acetylene (Fig. 14-a). The silica core appears peeled-off, while the two layer polymer coating may be seen from the diameter difference. Filaments of the soft inner layer (Fig. 12-a) exhibit the structure difference. The chemical analysis was performed pointing the layers similar to that presented in Figures 12 – 14 (b). As noticed in the chemical analysis, the silica cladding is indicated by Si and O peaks.

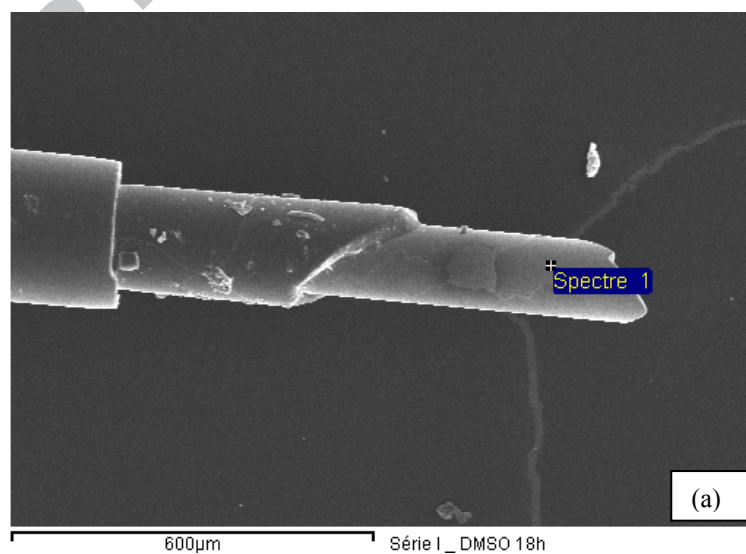
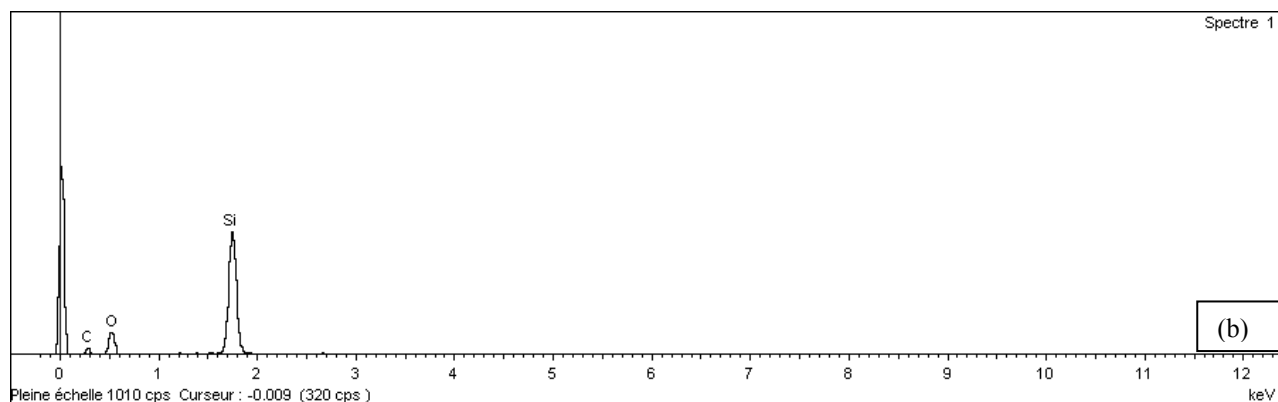
Figure 13. SEM (a) and chemical analysis (b) of DMSO aged SOF for 18 hours: polymer coating detachment

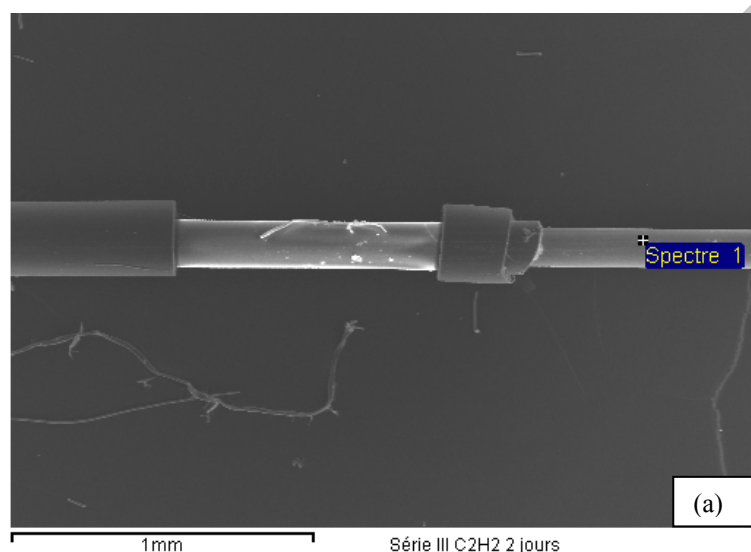
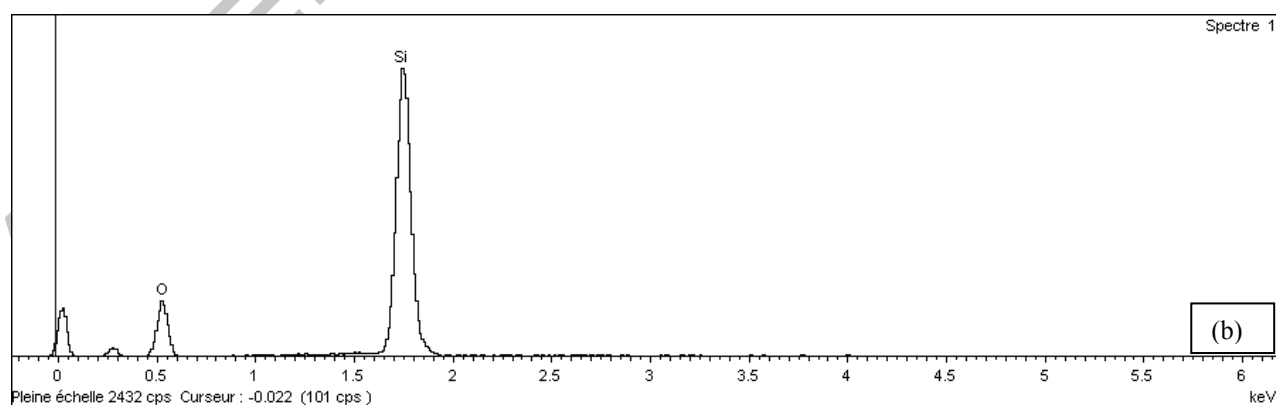
Figure 14. SEM (a) and chemical analysis (b) of SOF aged in acetylene for 48 hours: polymer coating peeling-off

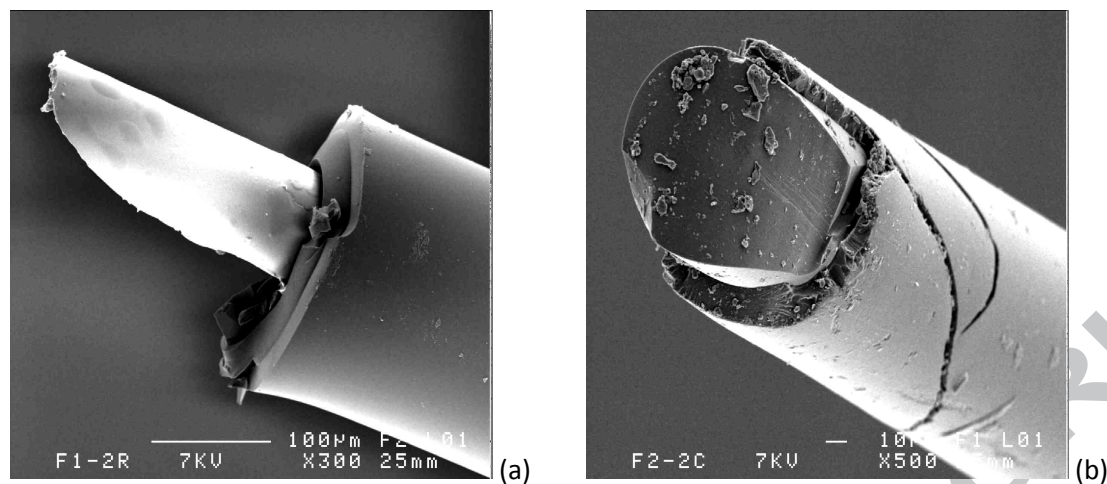
Figure 15. Optical fibre embedded in epoxy glass unidirectional composite system: polymer damage (a – double polymer coating; b- single polymer coating)

In particular structures, with SOF embedded in composite systems, detailed testing of SOF to components reactivity is needed. As previously presented [22] better coherence and adhesion at the OF/composite interface has been reported for the single polymer layer SOF 80/101.8. The polymer may be fractured (Fig. 15), but internal stresses seem more significant due to the polymerisation cycle of the composite resin in the case of the standard epoxy-acrylate SOF. The soft polymer layer appeared retracted or in other cases the silica cladding was stripped (Fig. 15-a); that's why the single layer optical fibre (Fig. 15-b) appear more adapted in these applications.
